DEVELOPMENT OF IMPROVED PERFORMANCE
HIGH SPEED SPIN BEARING & GYRO WHEEL
PROGRAM

FINAL REPORT

NAS-8-11356

National Aeronautics and Space Administration
George C. Marshall Space Center
Huntsville, Alabama

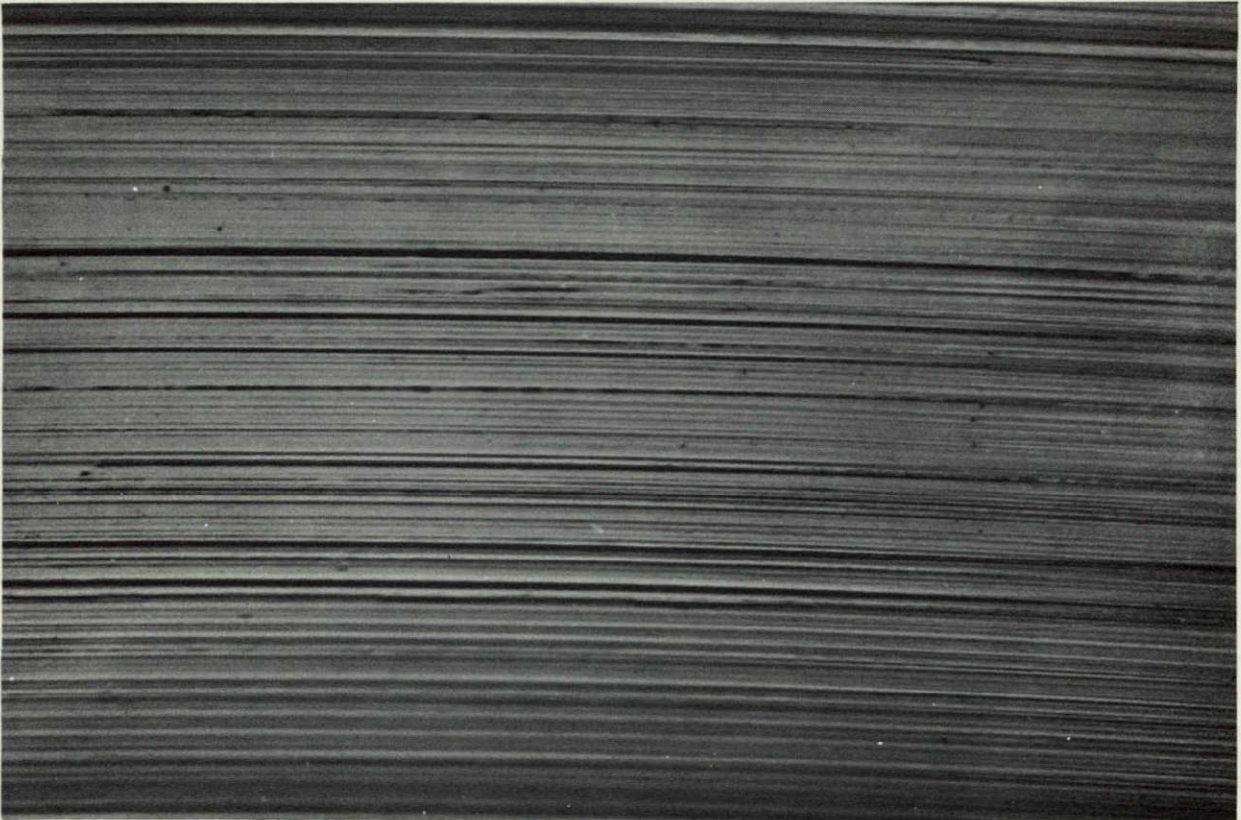
MRC E 13
Shaft #1 Side 500 X
Phase II

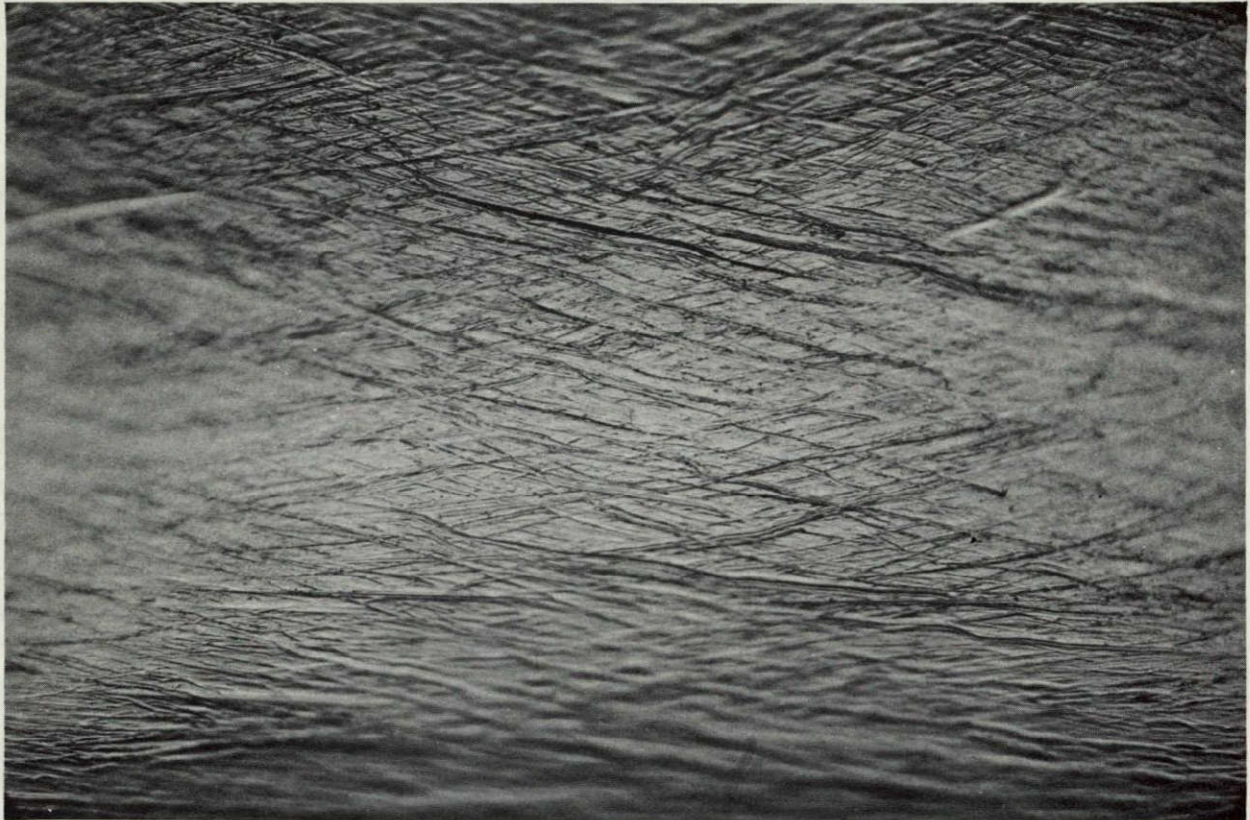
MRC F 11
Shaft #1 Side 250 X
Phase II

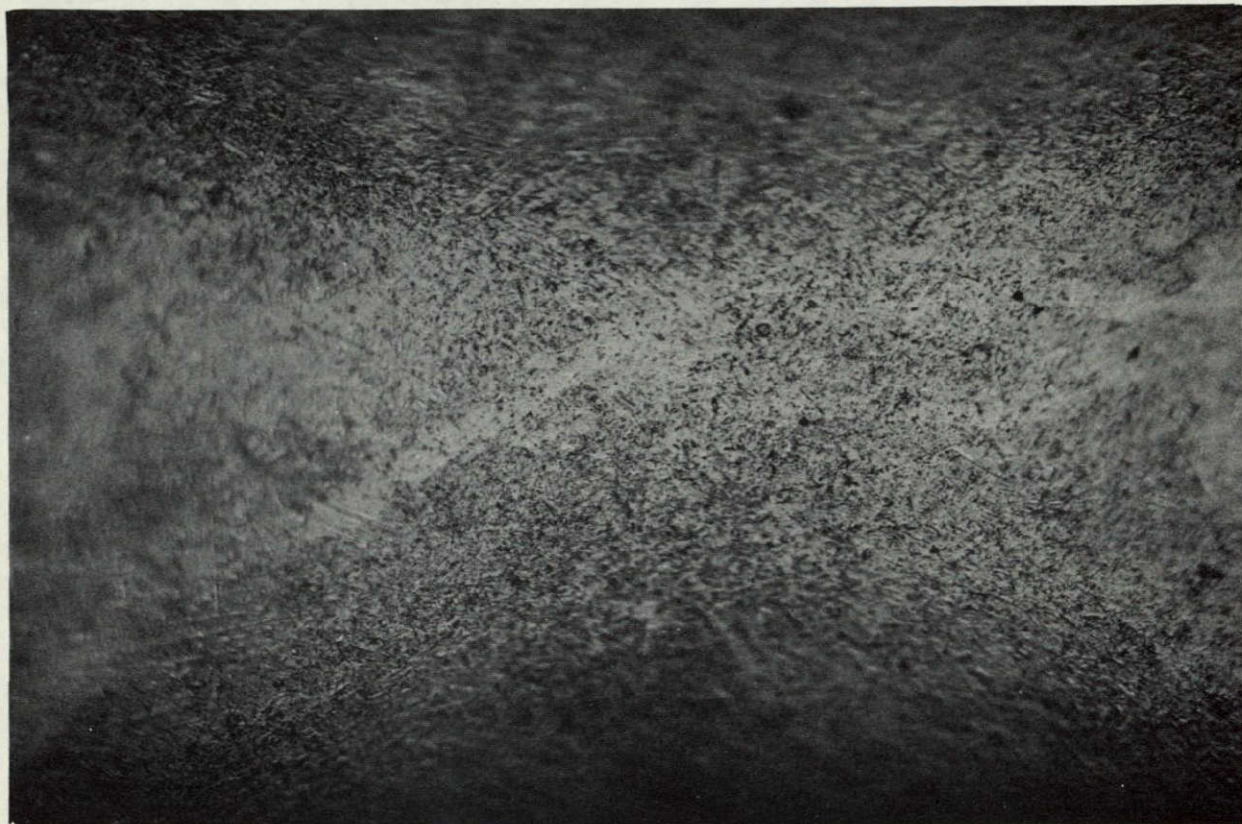
MRC G 12
Shaft #2 Side 250 X
Phase II

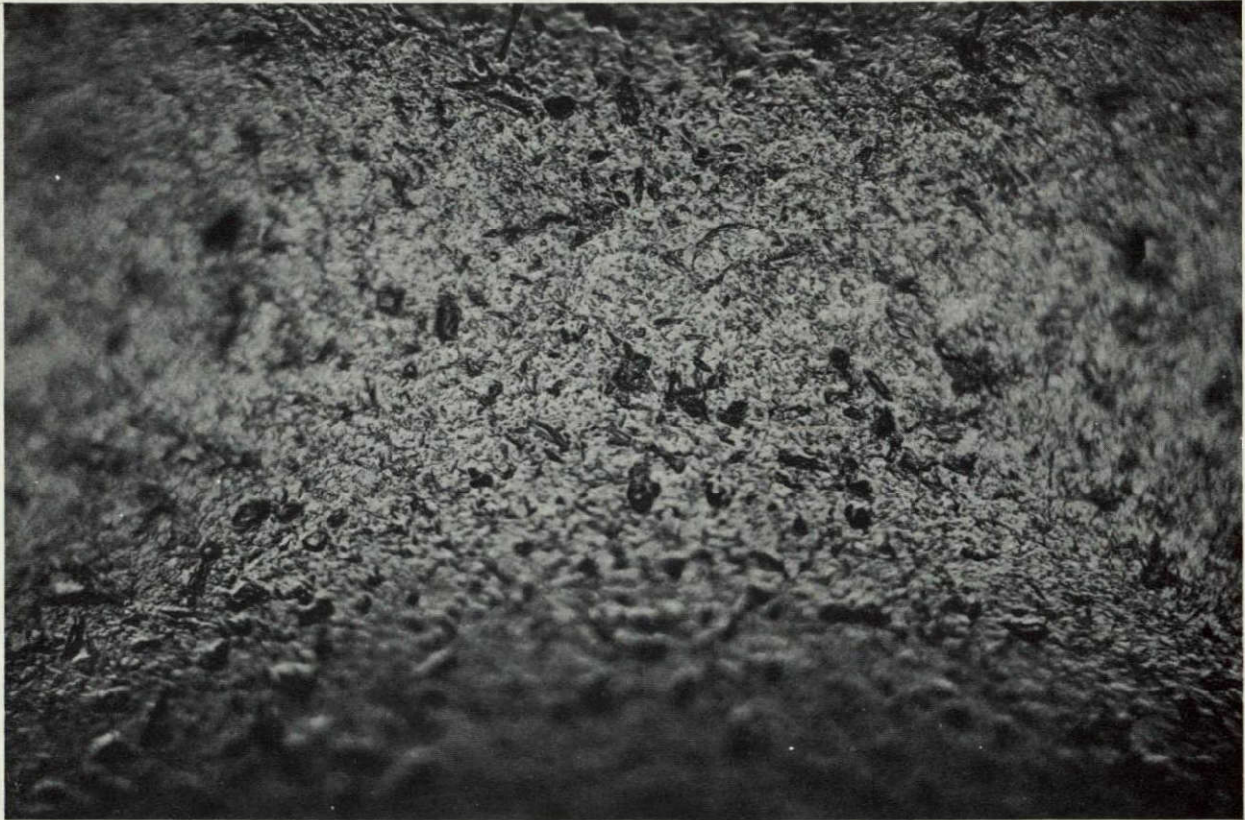
MRC H 4
Shaft #2 Side 250 X
Phase II

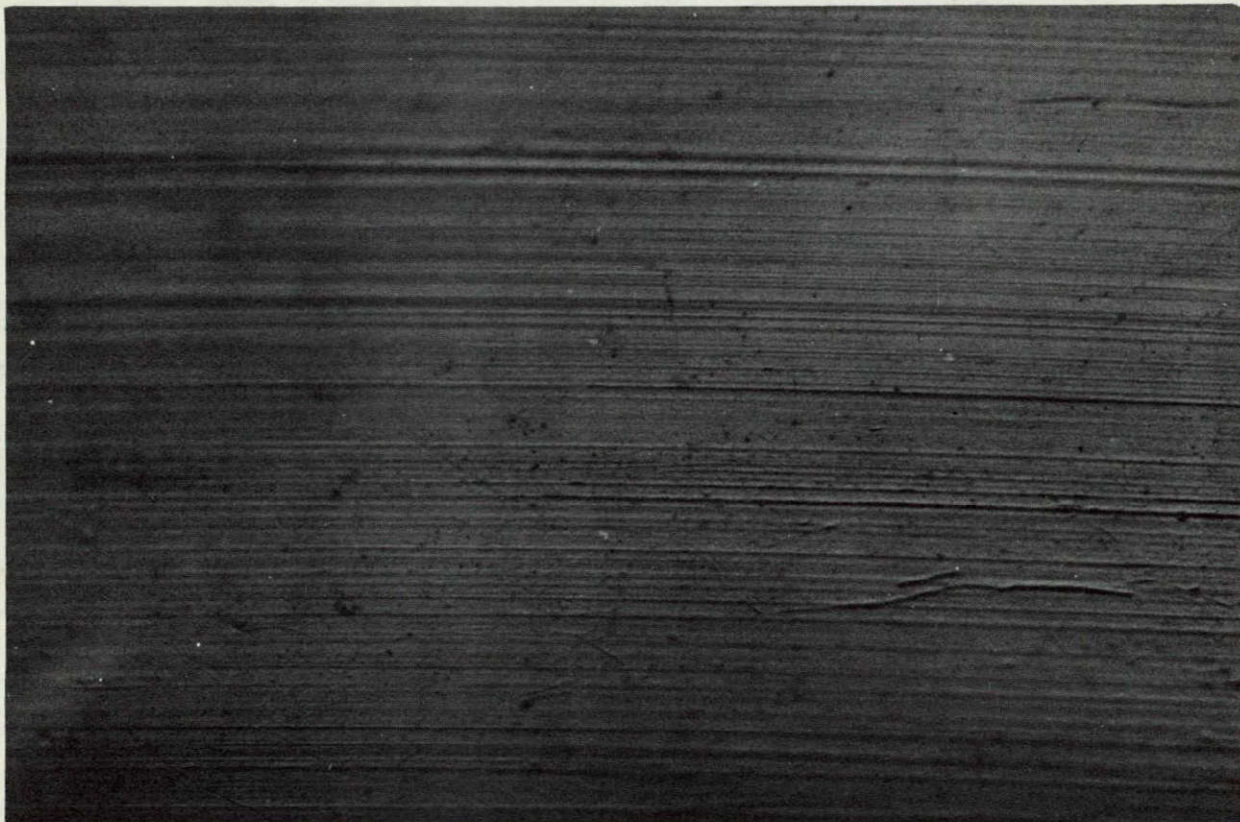
MRC I 1
Shaft #2 Side 500 X
Phase II

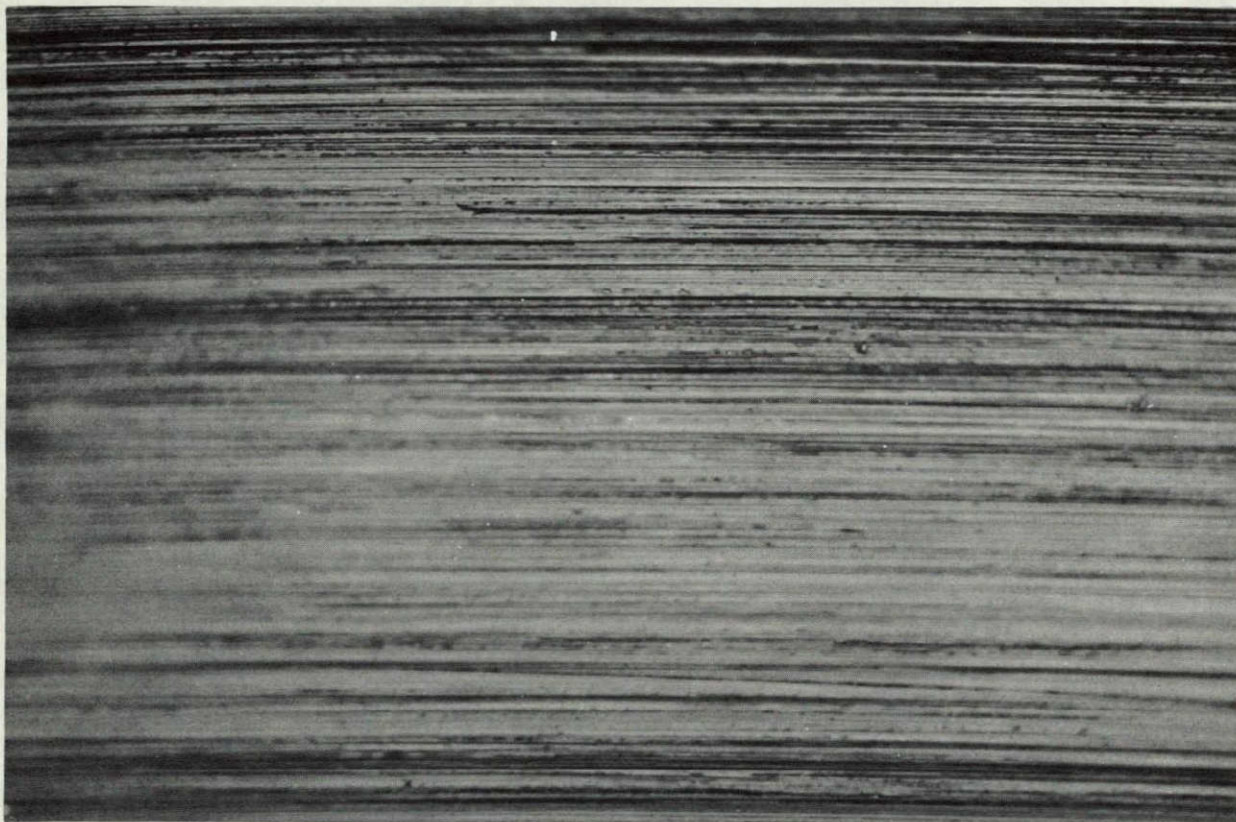
MRC C 22
Shaft #2 Side 400 X
Phase III
